Safety Alert - excavations

The Incident

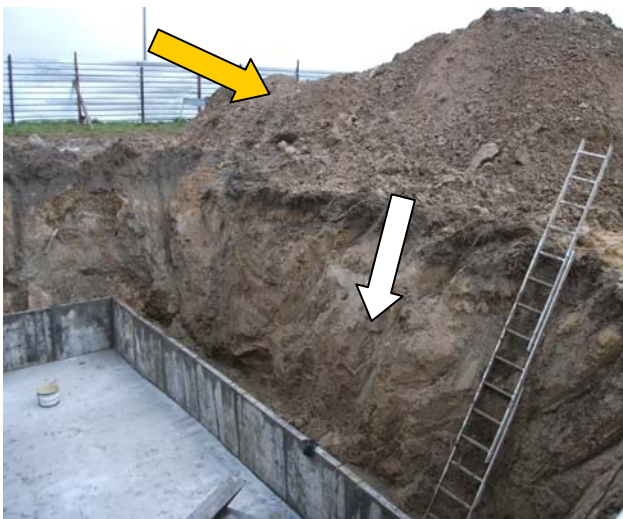
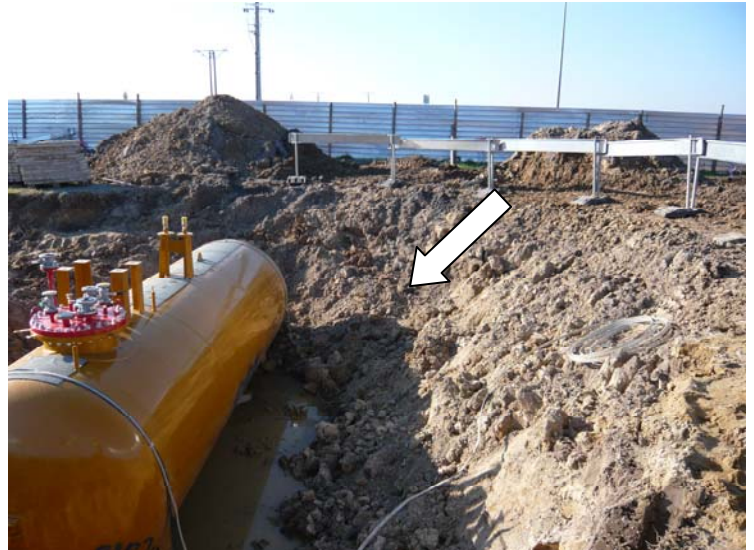
1. On the NTI site the excavations (app. 4 m depth) for fuel and LPG tanks were done by L3 without proper slopes or reinforcements;
2. The soil was stored too close to the excavation;

- The JHA did not describe in detail the method of carrying out the excavation;
- Coteba PM issued the PTW (without a clarification of the method for the excavation);
- L3 did not respect the HSSE requirements concerning the excavations included in the HSSE Construction Plan and the design;
- Coteba PM did not react on time (works were not stopped, the NMPI report issued too late);

- The soil stored too close to the excavations was relocated;
- The proper slope of the excavations were implemented;

- A detailed methodology of the excavations must be part of the execution design and must be reviewed and accepted during the tender and pre-construction phase;
- A detailed method statement / methodology of the excavation must be included in the HSSE Construction Plan of L3;
- PTW (JHA) must clearly state what the methodology of the excavations is;
- In case of non compliance with the agreed methodology works must be stopped;
