Incident Type: Near Miss Incident

## Matheson Shell – Mississauga, ON C10241

**FALL – CAR WASH SUMP**

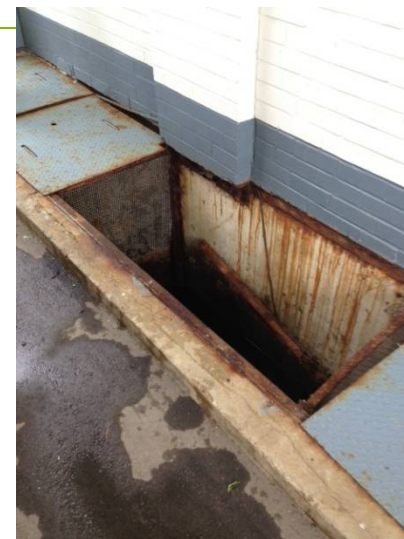
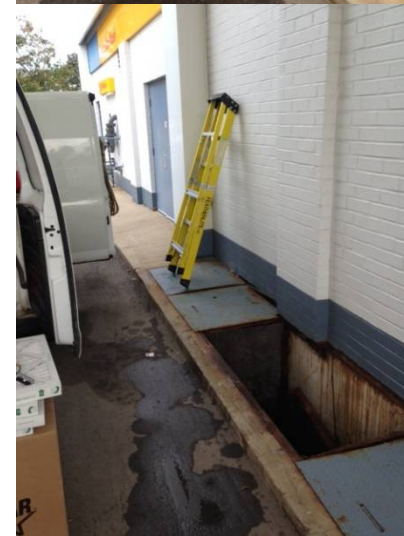
After arriving on site, the MTM donned his gear and proceeded to walk around the service van to meet the Mobile Technician. He walked on top of the metal plates covering the car wash sump area. The metal plates are nested on steel brackets which gave way and the MTM fell into the car wash sump pit. The sump pit was filled with approx 4' (1.2m) of water and sludge which cushioned the fall. The MT provided a fiberglass ladder to assist the MTM to climb out of the 8' sump pit (2.4 m). No injuries were sustained.

Car wash sump metal was significantly corroded and unable to sustain the weight of the MTM.

- Work with ROM and MT to make the area safe and initiate repairs / maintenance.
- Send notification / discussion with MTs and local contractors to highlight awareness for safety and alert to avoid walking on car wash sump covers.
- MT to inspect sites with car wash sumps for metal corrosion, fatigue and report back any findings for remedy

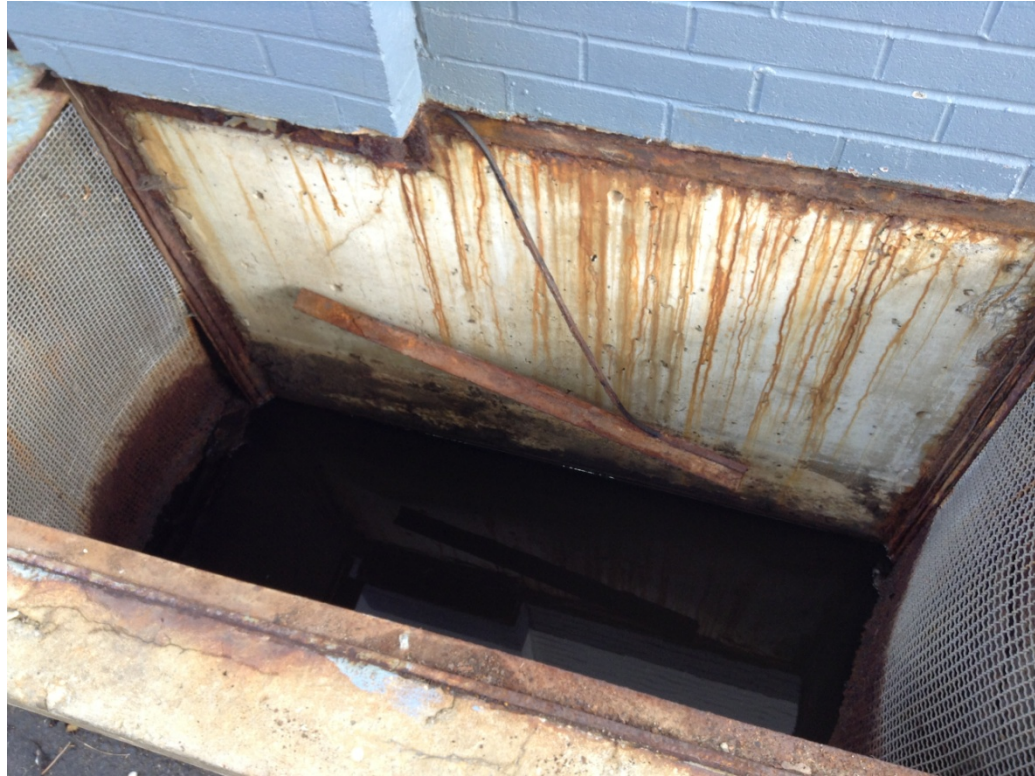
Car wash sump covers are submerged in approx. 1.2m liquid.  
Metal bracket fixed to car wash wall severely corroded and piece is hanging suspended at side of pit
