Asset Management Safety Bulletin: Safety Alert!

Damaged Equipment Must Be Identified and Replaced

First Aid Incident ProAct # 293541

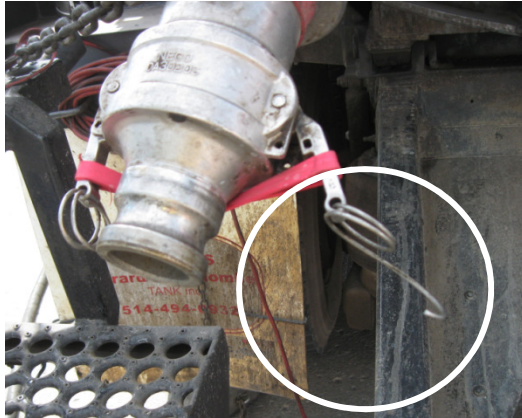
Pierced Finger from Metal Ring

A technician was using a vacuum truck to pump out a monitoring well at a retail location. The cam-lock fitting release mechanism had a damaged metal ring with a sharp protruding end. As the hose was being disconnected the sharp end of the ring pierced through the workers' glove and into his finger. First aid was provided and the finger was bandaged. Fortunately no stitches were required.

- The damaged metal ring was not identified when completing the safe work permit. Equipment and tools must be inspected before any task is started.
- Always take the time to replace any equipment or tool that is faulty or damaged.
- Never take short cuts to complete a routine task quickly.
- Complacency during routine tasks must be reduced to help eliminate injuries.
