## Site Fencing

### The Incident

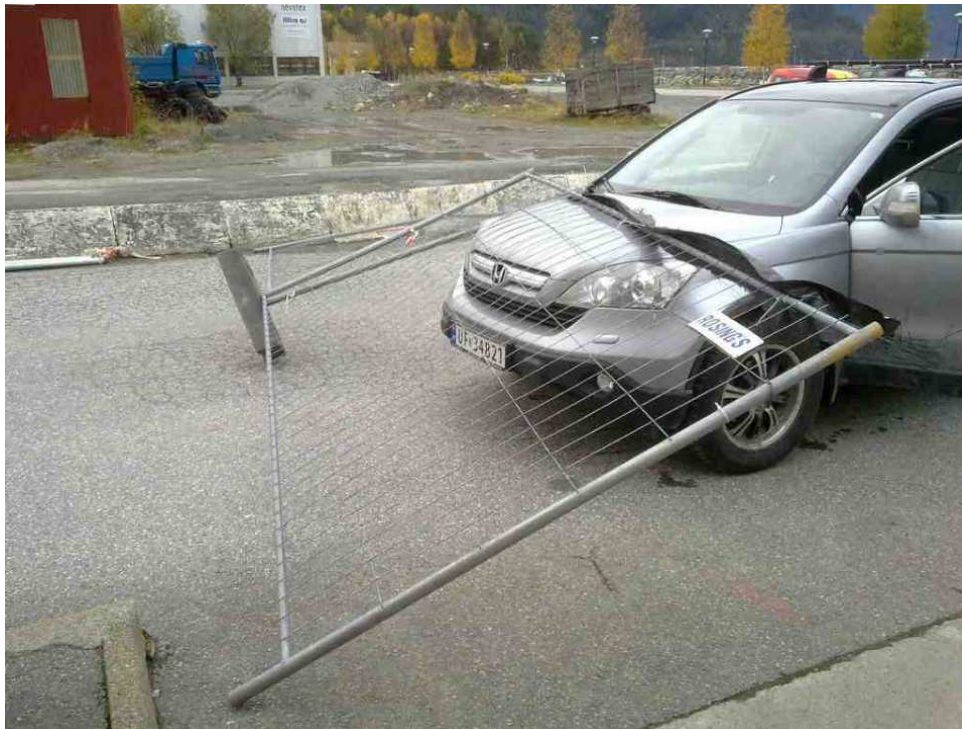
An L3 contractor was installing a tank at a station in central Norway. The tank was stored outside of the securely fenced working area, with a fence only partially around the tank. During a storm on a Saturday when no workers were on site, a station operative parked his car next to the fence. A gust of wind caught the fence which fell on to the front of the car, scratching it. No one was hurt.

- L3 Contractors must ensure fencing is adequate – not just to keep people out, it also must not be able to fall over
- Fencing standards are to be reviewed when on site by Coteba PM's to ensure:
  - Footings / bases are secure
  - All fence panels to be clipped together top and bottom
- All defects must be rectified during the site visit
