# Tank Replacement Alert

## The Incident

The L3 contractor was placing a tank in a deep excavation.

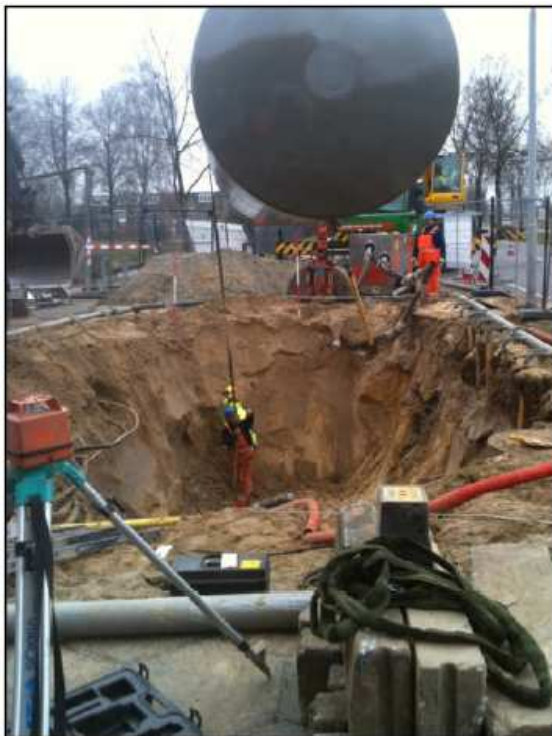
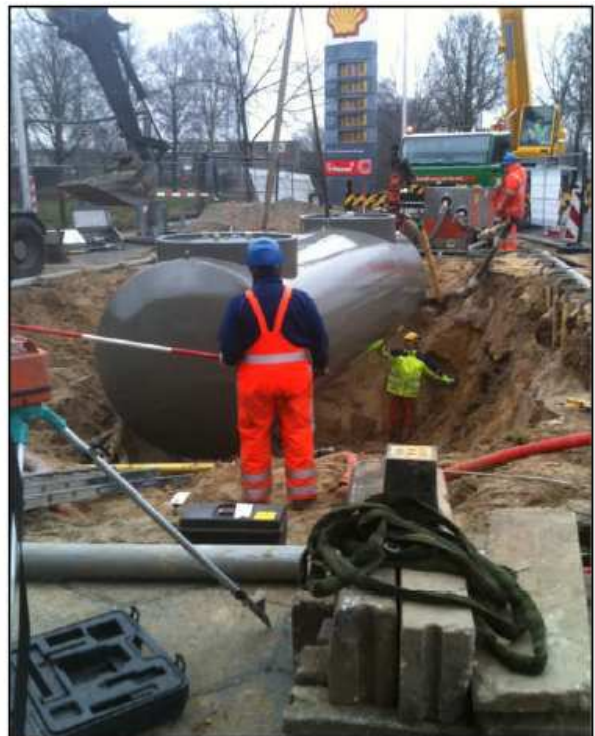
- While doing this, workers of the L3 were standing underneath the suspended load.
- The slopes of the excavation were not secured with trench supports or alternatively at the correct slope, posing a very high risk of the sides collapsing and the workers being buried alive.
- On the picture it is visible that only on one side ladders were placed for the workers to get in and out the excavation. The rules dictate that on two sides' ladders have to be placed. In case of an emergency the workers would have been trapped.
- On the picture it is visible that on the left side a ground working machine is parked, posing a high load on the top of the slope. The risk of collapse is high.

- The JHA did not consider that the slopes would be too steep and that ground reinforcing construction should be used. The site was so small that 1:1 excavation was not possible so the JHA should have included this.
- The Permit did not cover this steep slope. At the time the permit was issued the excavation had not been carried out but it should have been known that 1:1 was not possible. Conclusion is that the work preparation was not sufficient.
- Although the workers knew working under a suspended load is prohibited under the Life Saving Rules, they still worked under it.
- The PM in charge of the project did not issue the permit but a colleague did. This colleague was aware of the conditions but there was no documented hand over.
- There was no excavation or lifting plan.
- LMRA was not used.
- No NMPI was reported.

- Coteba consequence management was applied –
  - Banning workers on the Shell Project for Coteba
  - Suspending the company for the next three tank replacements.
  - Coteba PM's will receive training again to increase the awareness of the risks and HSSE rules.
  - For all sites where we know we will have to excavate we will make excavation plans upfront, starting immediately when the project or program is started.

- Always follow the Life Saving Rules, no matter what!
- Preparations were too poor. If this work had been prepared well, the slopes of the excavation would have been protected using a soil reinforcing structure. The JHA could have been prepared better, workers better informed, etc, etc, etc. **So prepare all sites upfront.**

- In case of an excavation and slopes can not be 1:1, an excavation plan has to be drawn by an expert. Even if the slopes can be 1:1 it is possible that a ground reinforcing construction has to be placed. In the case of Den Bosch the excavation was kept dry by pump drainage. If this system fails it is possible that the ground water raises so high that slopes can still collapse even with a slope of 1:1.
