Poland Incident - LFI

Safety Alert

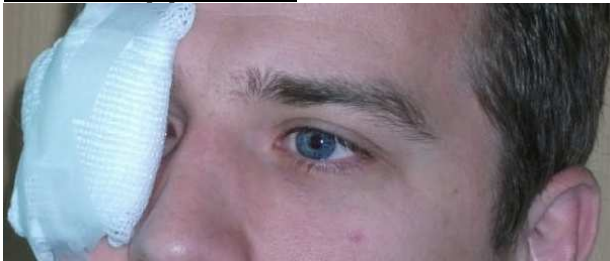
- 1 worker went to get his eye protection but the other started work; it is likely without putting eye protection on.
- He slipped, the disc jammed and when it came free it broke up and some of it hit his right eye.
- The end result – his right eye was so badly damaged it had to be removed at the hospital.

- Poor quality control (in this case not checking the reinforcing bar before starting the concrete pour) can start a chain of events which affect workers safety
- work activity's must be planned
- JHA's must be followed
- Correct eye / face protection must be worn when required
- Although designed for metal cutting, the angle grinder was not the best equipment for the job – bolt croppers would have been better – less hazards (no electricity, no sparks, and no high speed discs which could break up...)
- The LMRA (Last Minute Risk Assessment) must be carried out
