Asset Management Safety Bulletin: Safety Alert!

Re-assess Procedures When Work Conditions Change

Recordable Injury ProAct # 300465

Dislocated Finger / Lost Time Injury

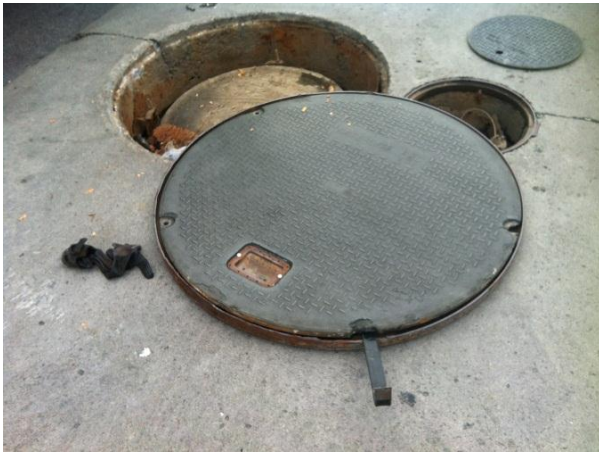
A technician was removing a submersible sump cover plate. The cover plate handle was damaged and the worker was using a prybar to separate the cover plate from the metal sump support ring. The support ring became dislodged from the sump and pinched his finger between the ring and plate. The force of impact resulted in the dislocation of the workers' finger. After seeking medical attention the worker was unable to return to work for 2 days. This lost time injury could have been prevented.

- The JSA should have been re-assessed when the technician was having problems removing the sump cover plate.
- Different tool options should have been identified and assistance requested to complete the task.
- If working conditions change, new hazards must be identified and appropriate action taken to eliminate all hazards.

- Our tolerance to risk must be reduced when performing all tasks including routine work.
- Last Minute Risk Assessment (LMRA) is a behavioral base tool to reduce and eliminate our exposure to hazards.
- By identifying and eliminating potential risk we can lower our tolerance to risk.
- Safety is our #1 priority and must be second nature to us all as we continue to develop a strong safety mindset and culture.
- By reducing our tolerance to risk we can reach our goal of "Zero Injuries".
